The Martian Landscape

By The Viking Lander Imaging Team

Scientific and Technical Information Office
NATIONAL AERONAUTICS AND SPACE ADMINISTRATION
Washington, D.C. 1978

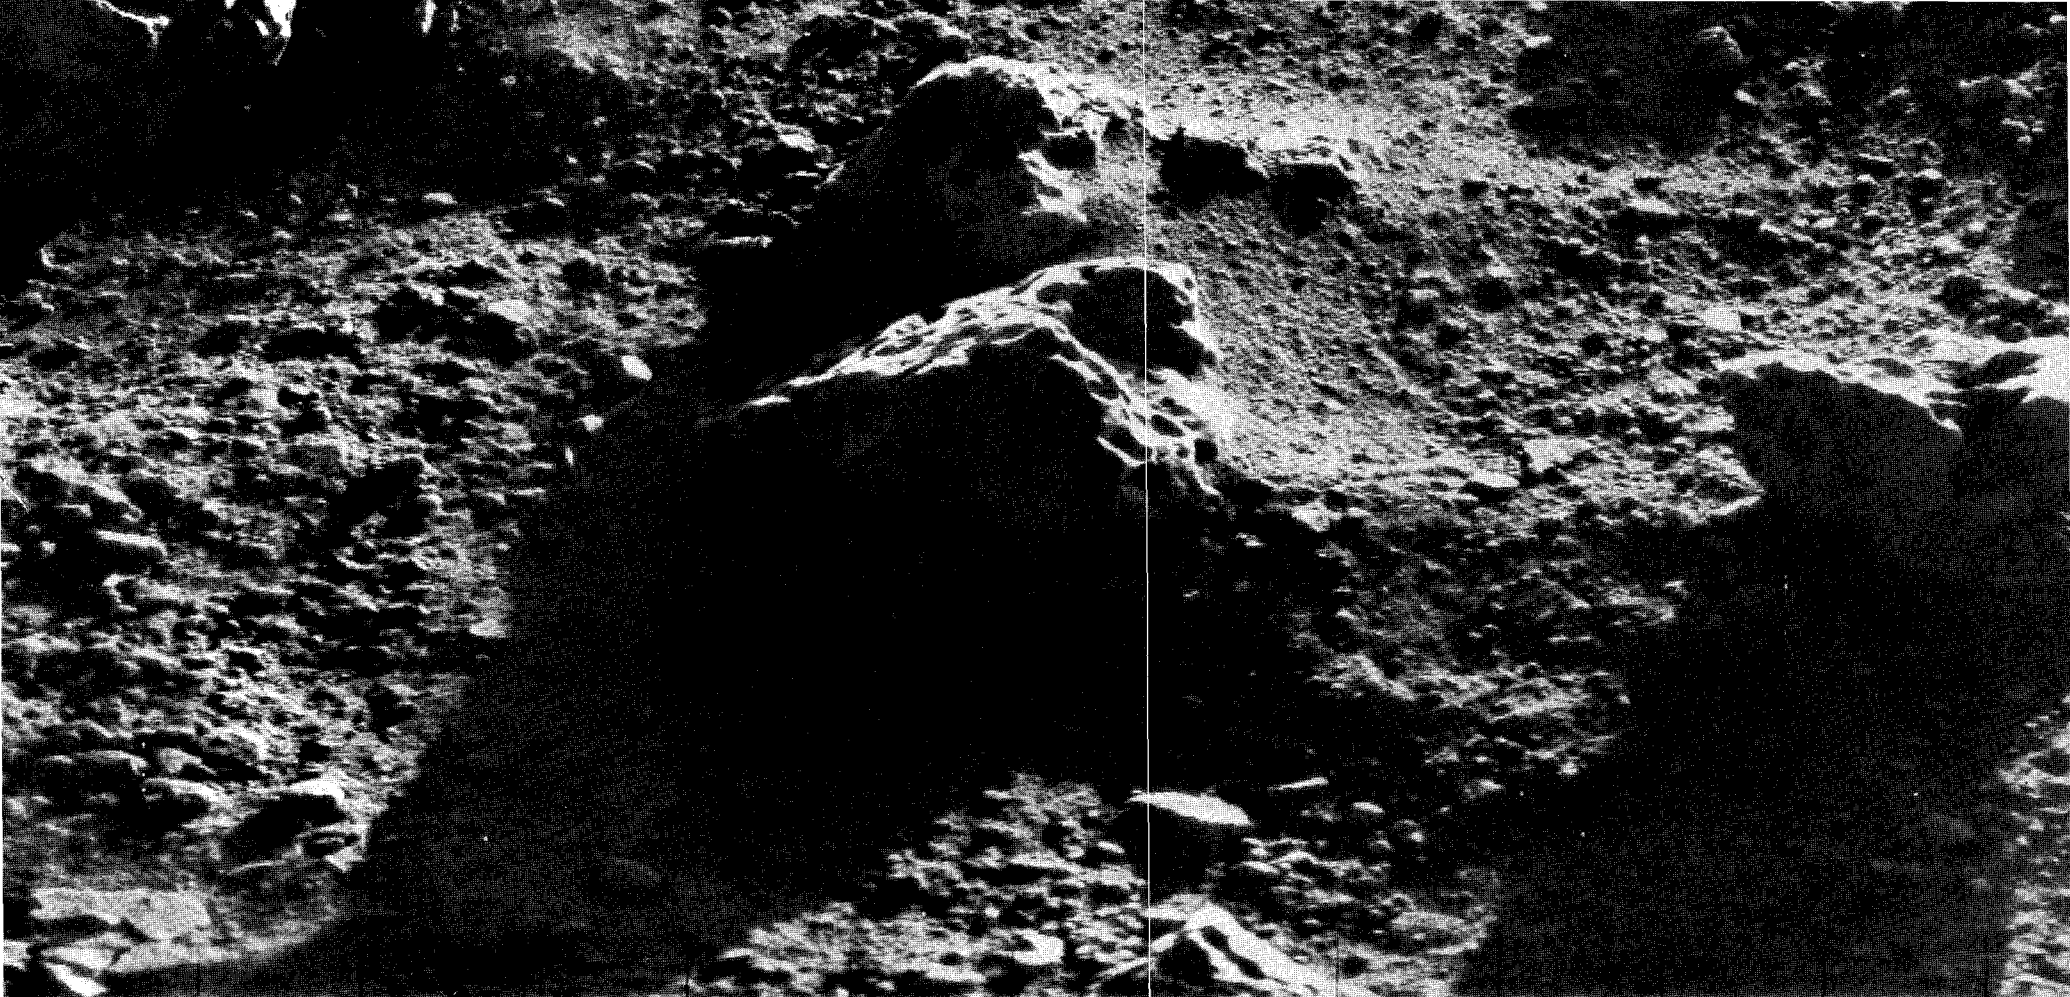
FIGURE 134

Oblique lighting in figure 134 accentuates pits so large they look like small craters. Indeed, if Mars lacked a shielding atmosphere that destroyed small

meteoroids, an impact origin for the pits probably would be favored.

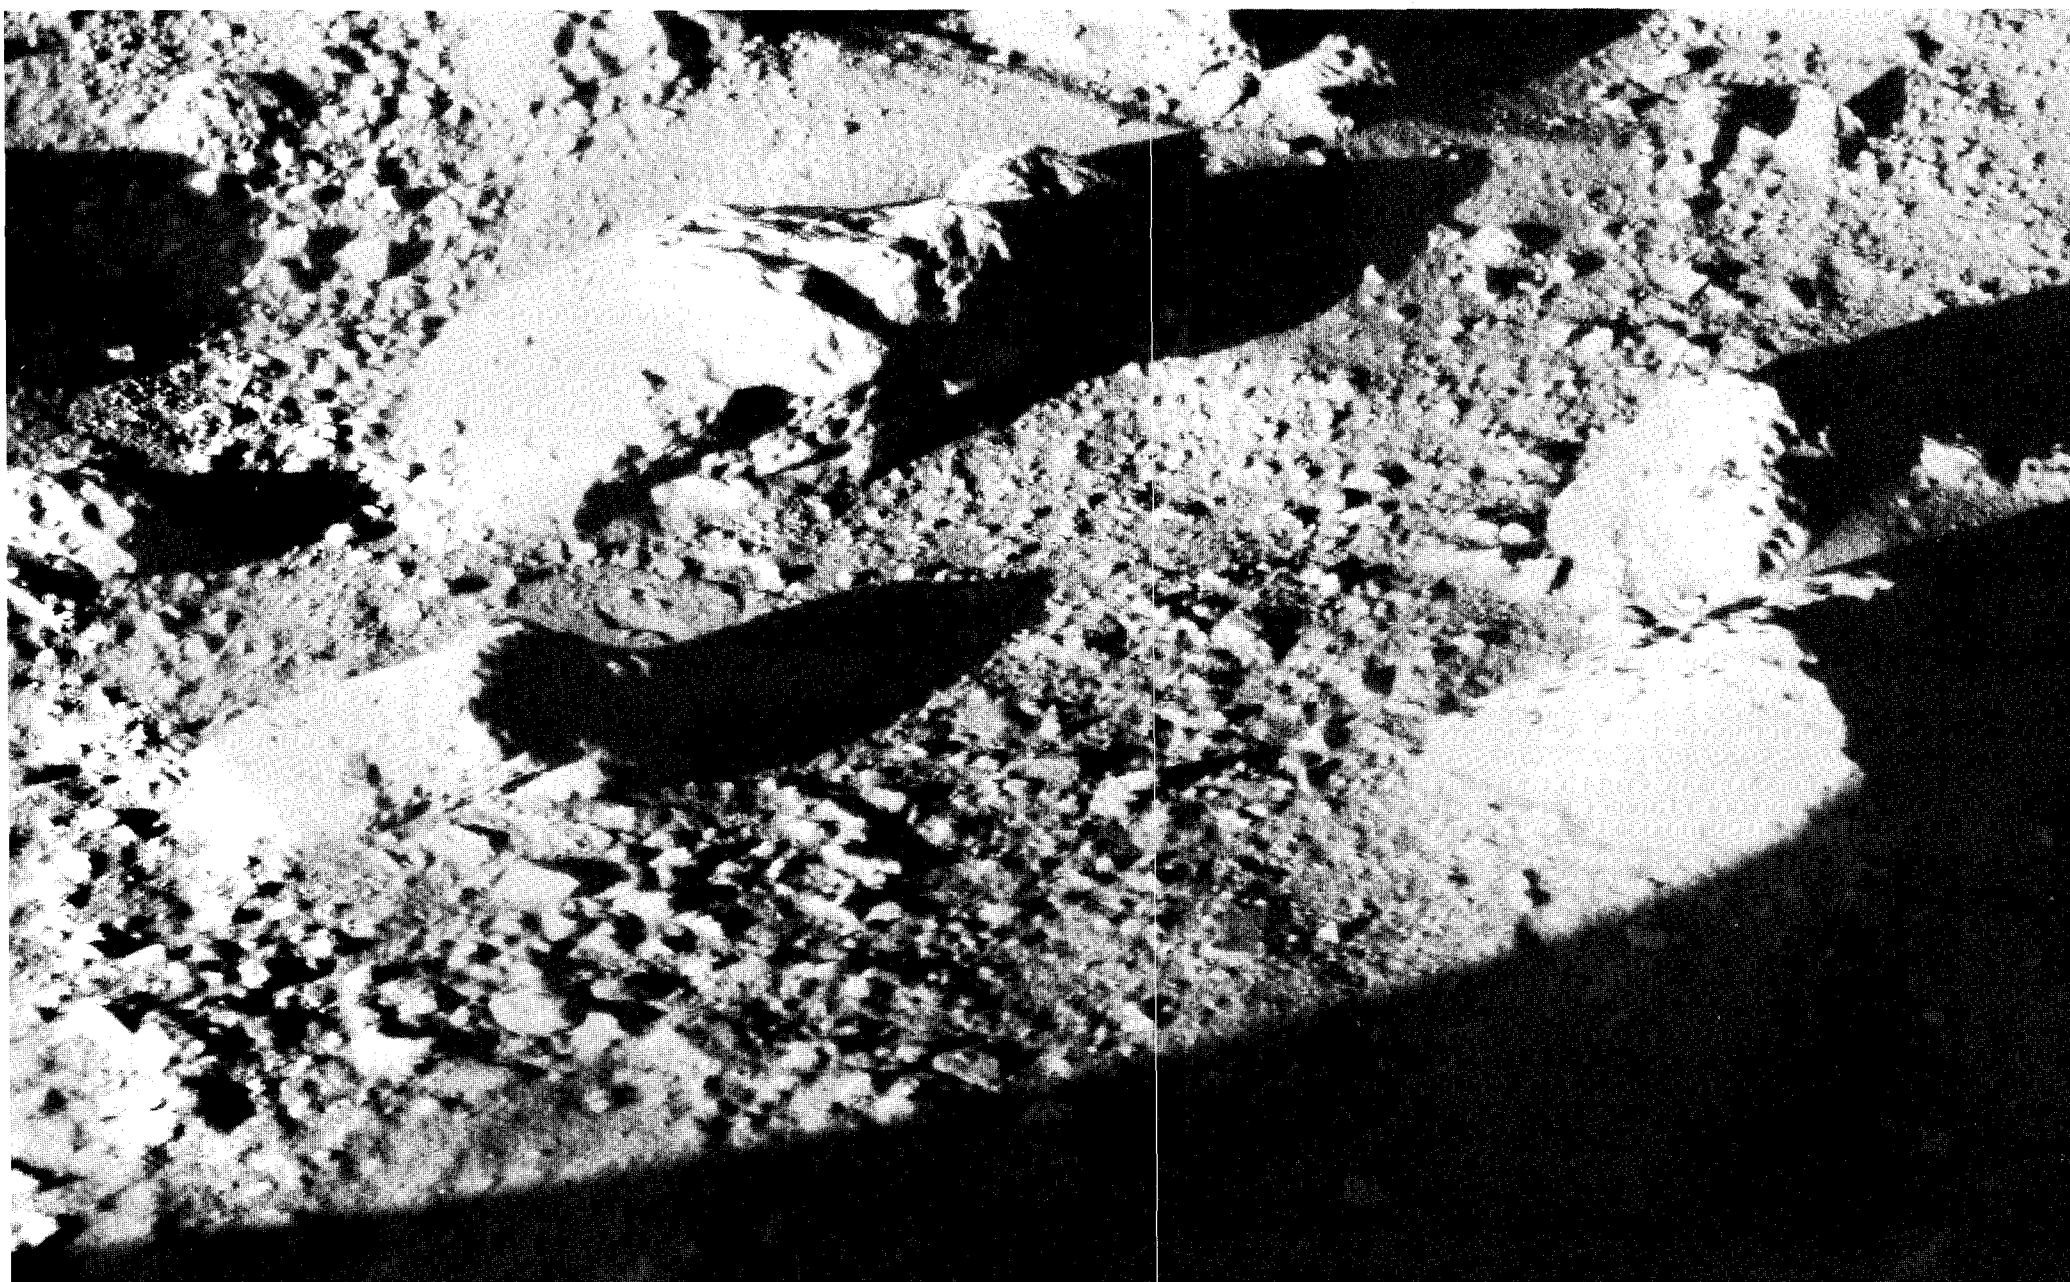
FIGURE 135

The spacecraft shadow in the lower part of figure 135 creates an attractive graphic design. Note that the right part of figure 135 is the same field of view as the left center part of figure 134.

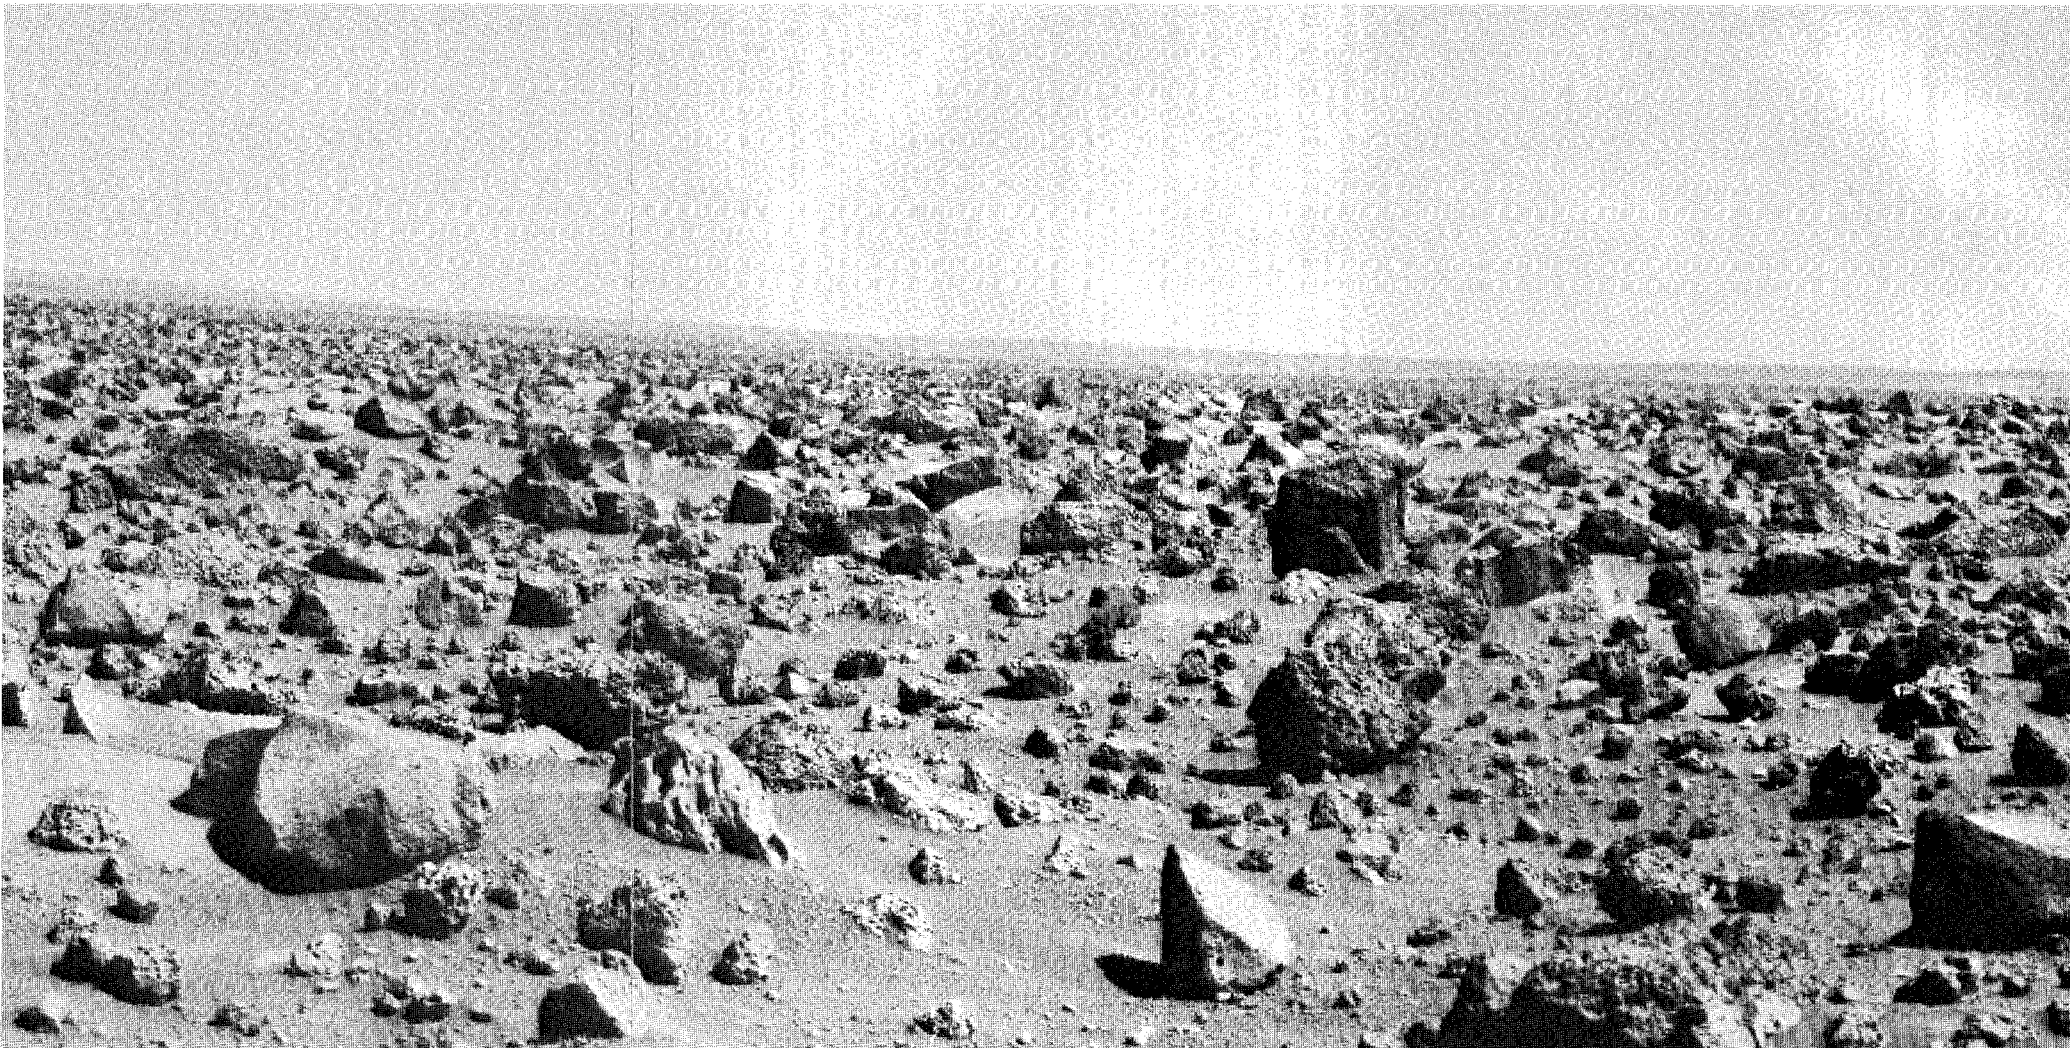
FIGURE 136

This panorama of almost 100°, looking toward the east, is broken into two segments, figures 136 and 137. In figure 136 a sequence of increasingly distant ridges can be identified. In the right half of figure 137 a block-studded crest close to the spacecraft obscures the distant horizon. The general slope of the horizon is a consequence of spacecraft tilt, not of any natural gradient in the scene. Indeed, the horizon is almost exactly level, displaying significantly less relief than the distant landscape at the Viking 1 site. By coincidence the farthest horizon appears at the lowest point in the tilted image.

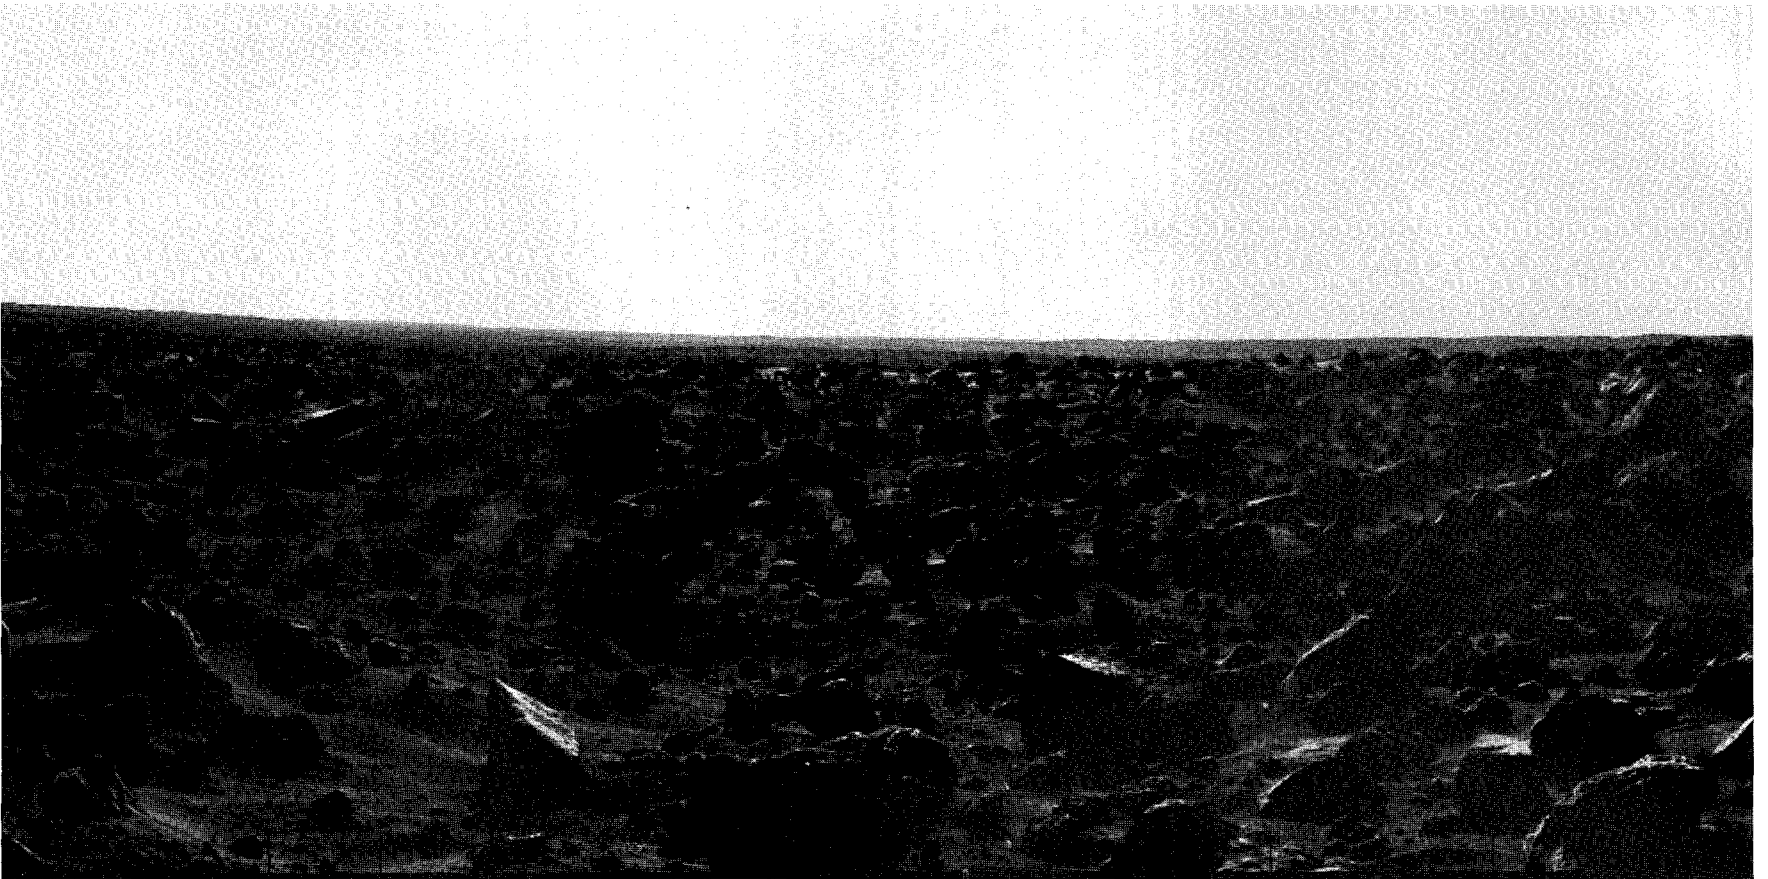
FIGURE 138

Figures 138, 139, and 140 show horizon ridges photographed at three different times of day. Predictably, change in illumination results in different reflections from the broad slopes. Only by reference to all the available pictures can a viewer gain a true impression of the complex detail in the distance. Figure 138 is purposely printed dark to bring out the relatively light horizon details.

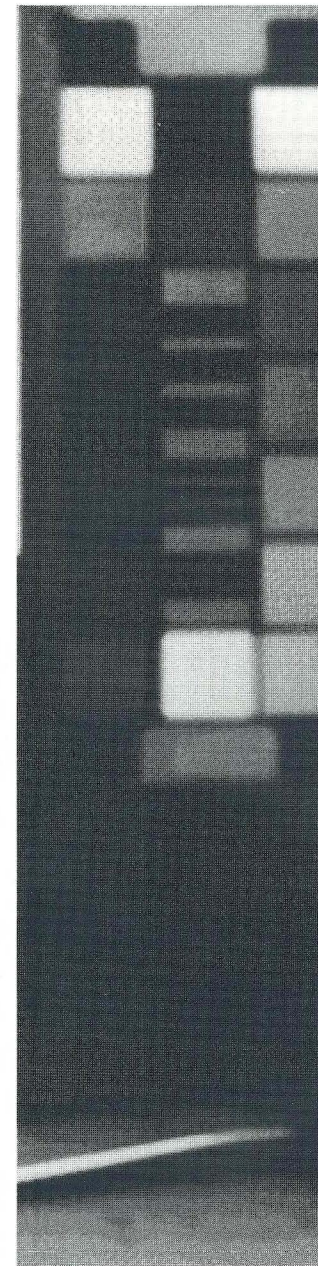
FIGURE 144

A more conventional camera test is imaging a target mounted on the spacecraft (fig. 144). Actually there are three identical targets, two of which are visible with either camera. Square patches of red, green, and blue paint assist in establishing color balance. A series of gray chips with varying brightness calibrate sensitivity of camera diodes and associated electronics. Groups of bars with different spacing indicate the camera's spatial resolution, much as we determine the quality of our own vision

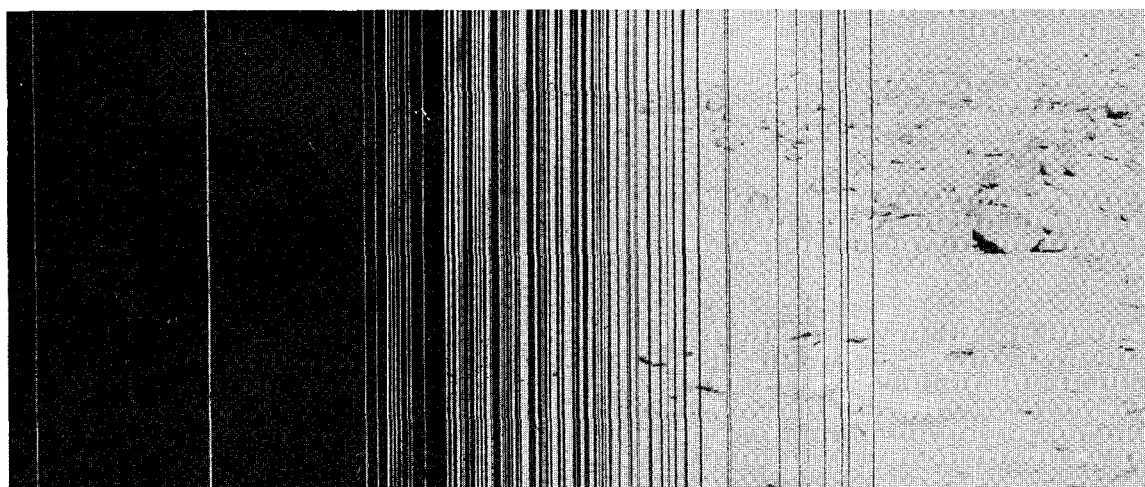
FIGURE 145

In figure 145 the data loss occurred during the Lander to Orbiter relay. As the Orbiter rose above the horizon, the received signal from the Lander became progressively stronger. The initially weak signal caused a large number of "bit" errors. In many instances the computer was unable to locate the beginning of a line in the telemetry stream. Reprocessing of the data located most of the image data that was present but misaddressed (fig. 146).

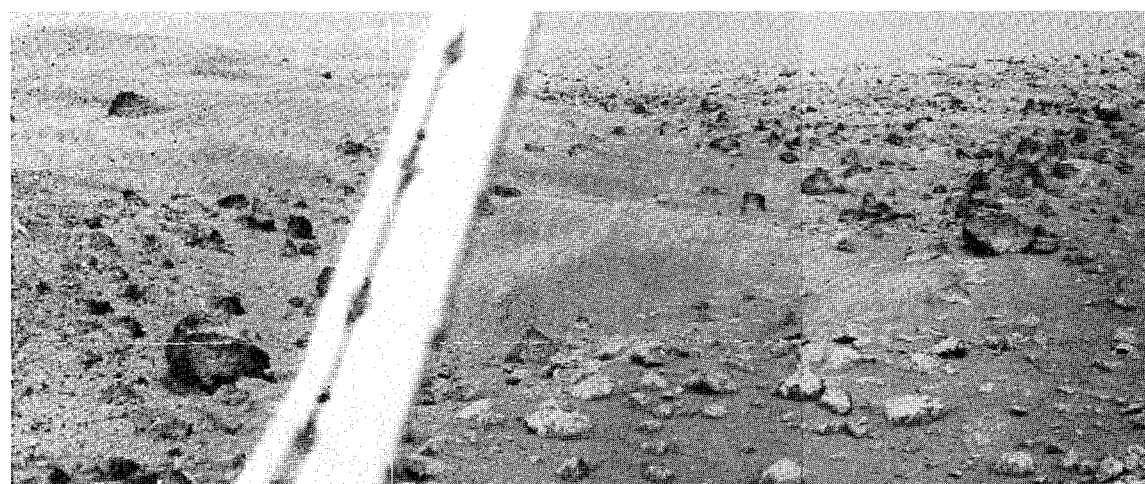
FIGURE 147

The contrast of a picture can be increased. In figure 147 the brightness values of constituent pixels have been "stretched" to encompass a larger range of gray levels. Most of the brightness numbers recorded by the camera were clustered between 8 and 40. To increase contrast the limits of the distribution were reassigned values of 0 and 63, and intervening brightness numbers were stretched linearly. The result is that the bright pixels are brighter while the dark pixels are darker.

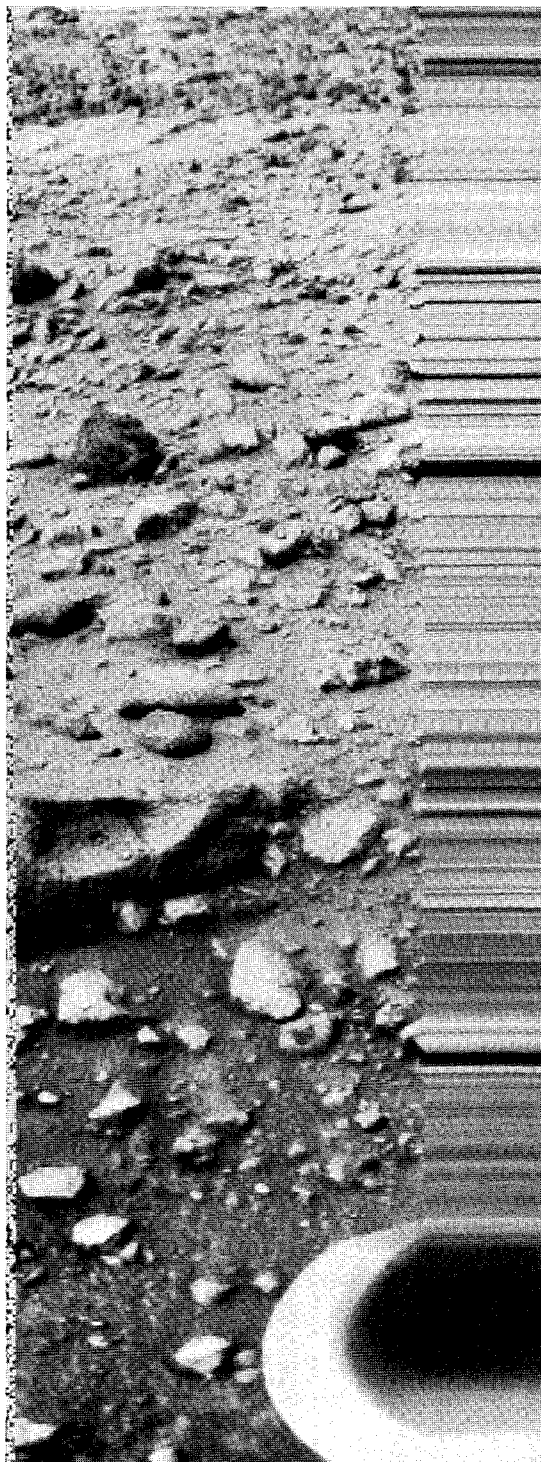
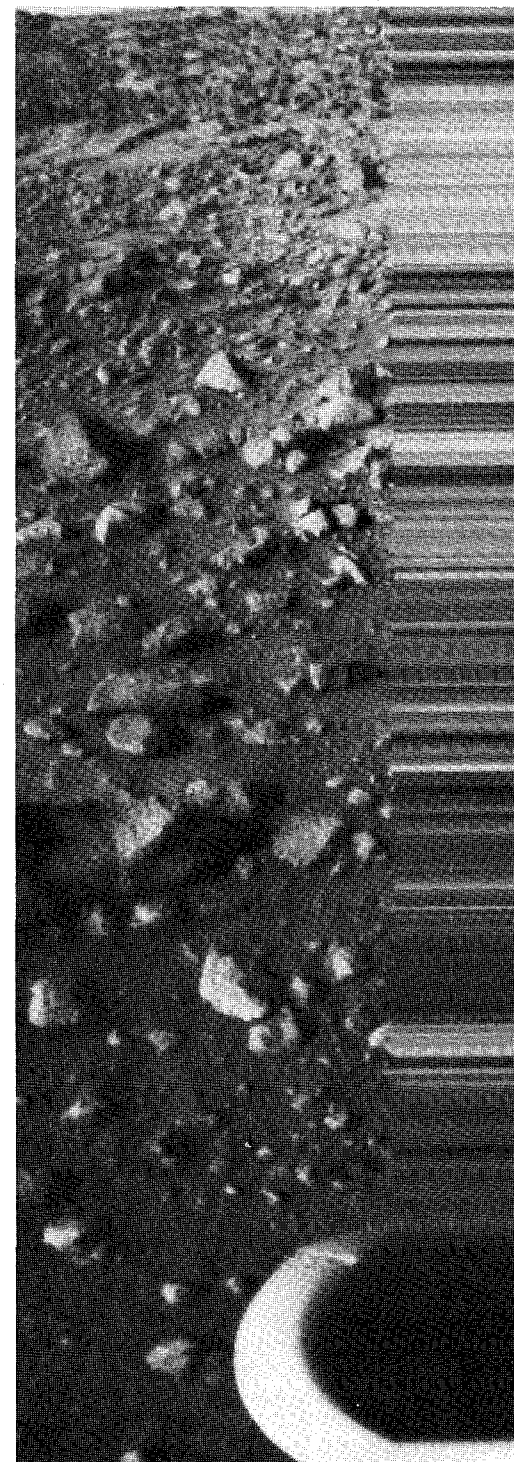
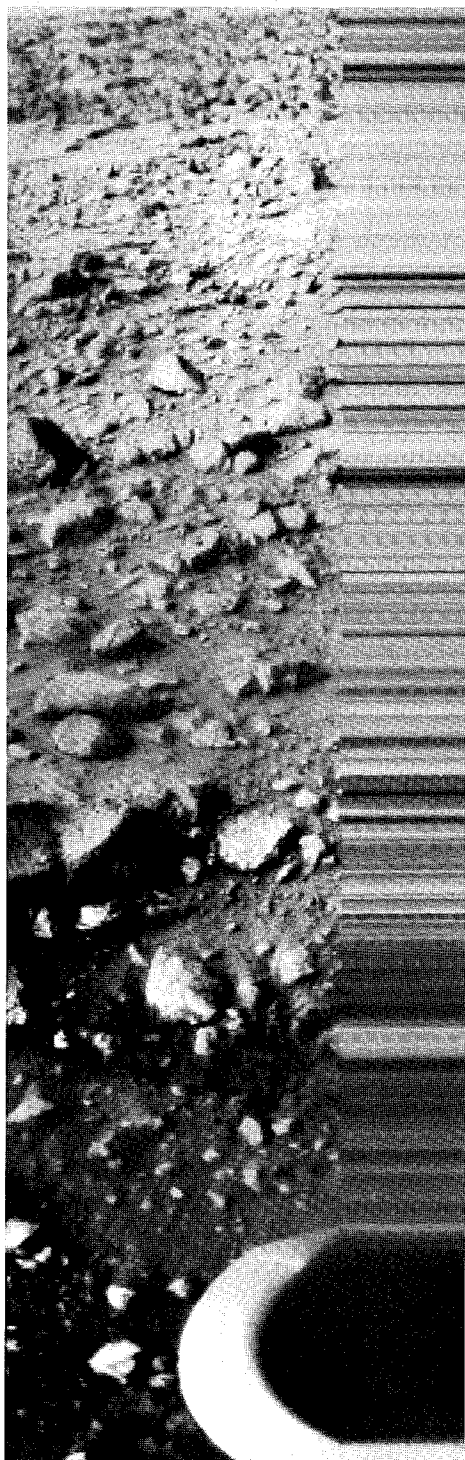
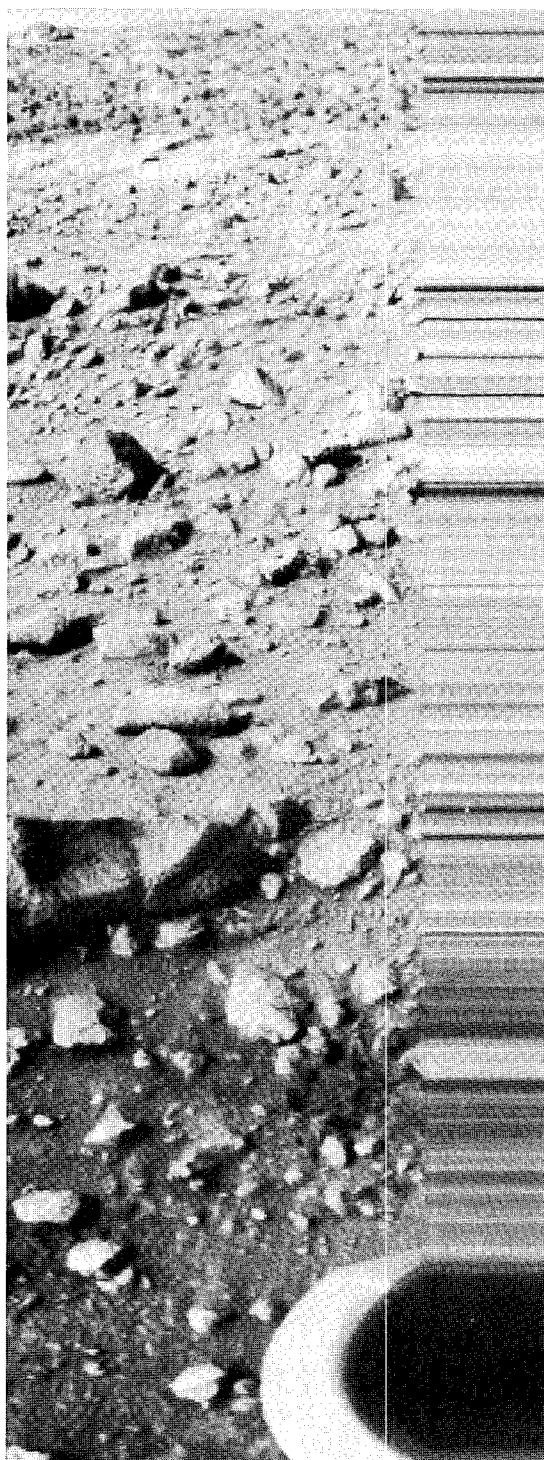
One of the prime objectives of the imaging investigation was to document changes, either rapid or long term, within the scene. Figures 148 through 151 are a series of pictures of footpad 3 at the Viking 1 site. Taken over a period of several days, these pictures record slightly different shadow patterns corresponding to different times in the morning. No other changes are apparent. Similar monitoring sequences were used extensively throughout the mission to photograph regions that seemed the best candidates for change. The most valuable sequence of repeated images documents the formation and decay of a frost cover at the Viking 2 site (figs. 194 to 196).

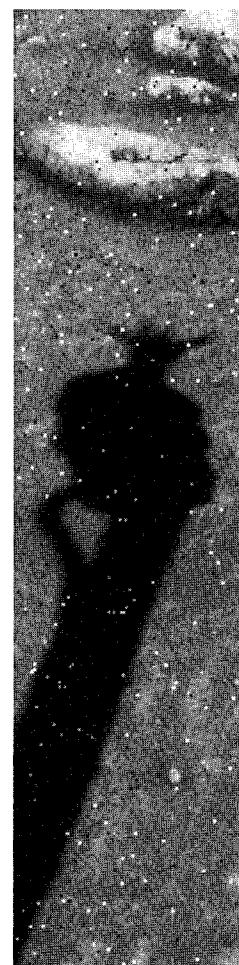
FIGURE 152

Figure 153 shows an exotic example of the motion in the martian scene. As the shadow of the meteorology boom moves from left to right, repeated scans through a single vertical line create a pseudo image. Note that this is the mirror image of the boom shadow as it actually is

projected on the martian surface at any instant (fig. 152).

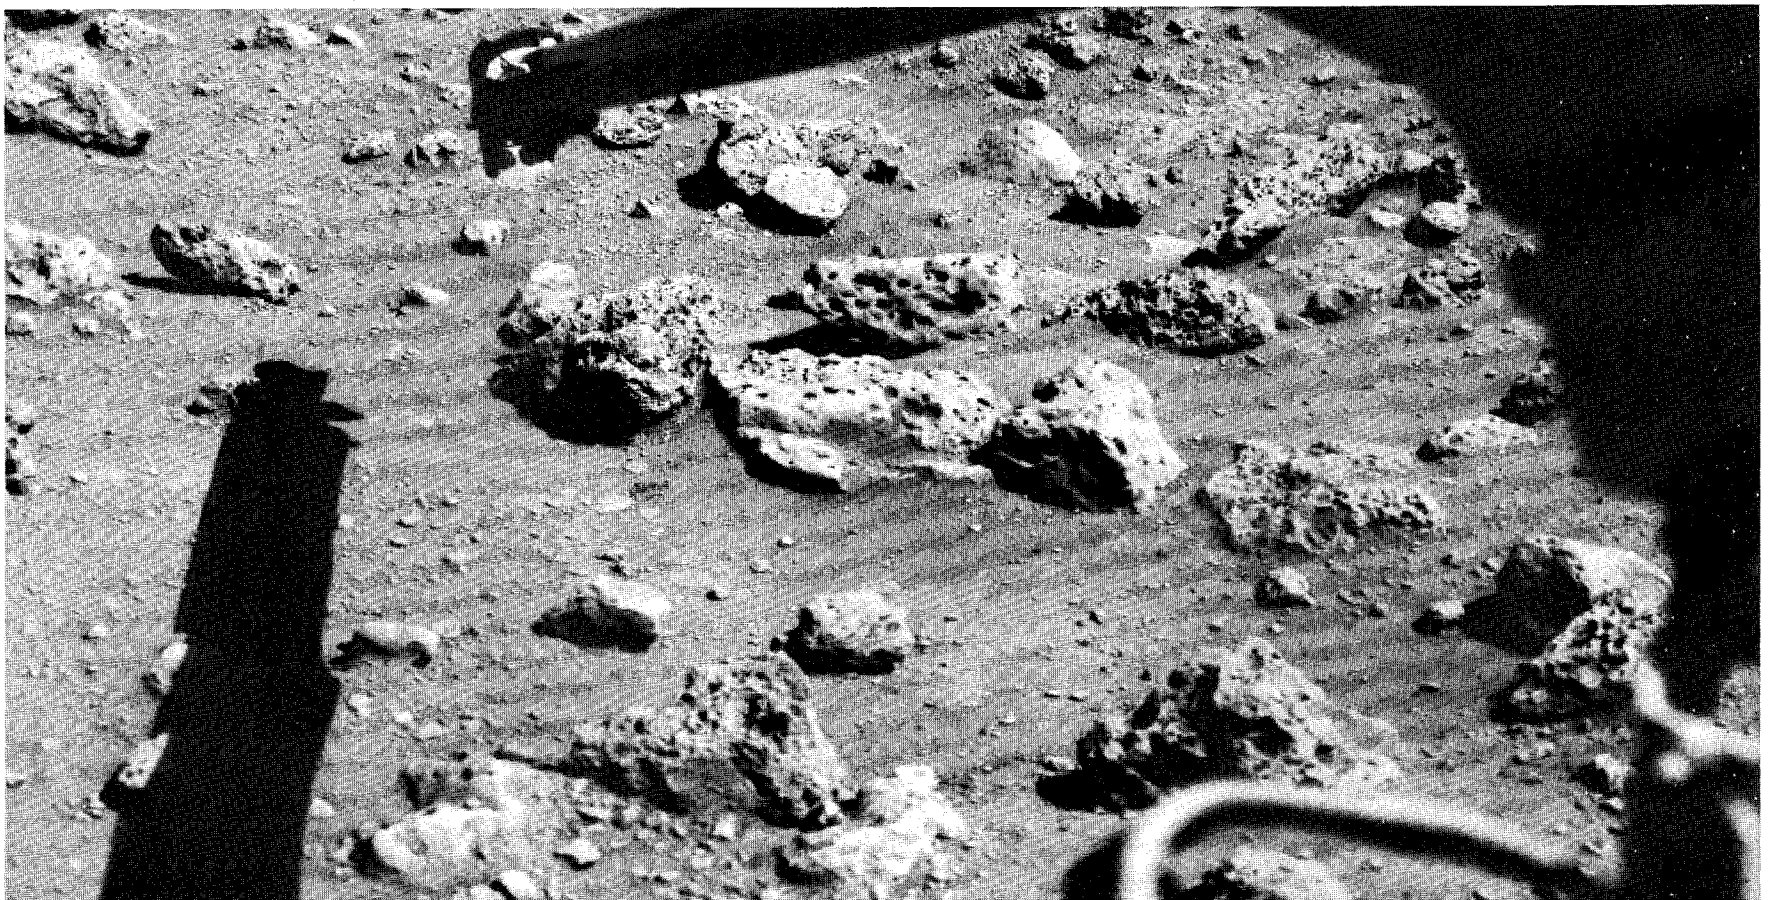
FIGURE 155

Acquisition of soil samples for analysis within the Lander was the single most demanding Viking activity, requiring the integrated contributions of many scientists and engineers. In the course of the mission the surface sampler arm was deployed many times; numerous trenches were dug and many samples were delivered to instruments within the spacecraft. Figures 154 and 155, which show the extended sampler arm on Viking 2 from the vantage point of both cameras, capture the essence of a sampling operation. Figure 156 shows the same region after several trenches have been dug and one rock pushed a short distance. The trenches are visible at the far left and far right. The displaced rock, nicknamed Mr. Badger after a character in *Wind in the Willows*, is near the middle of the picture. Mr. Badger is seen in its original position in figure 155.

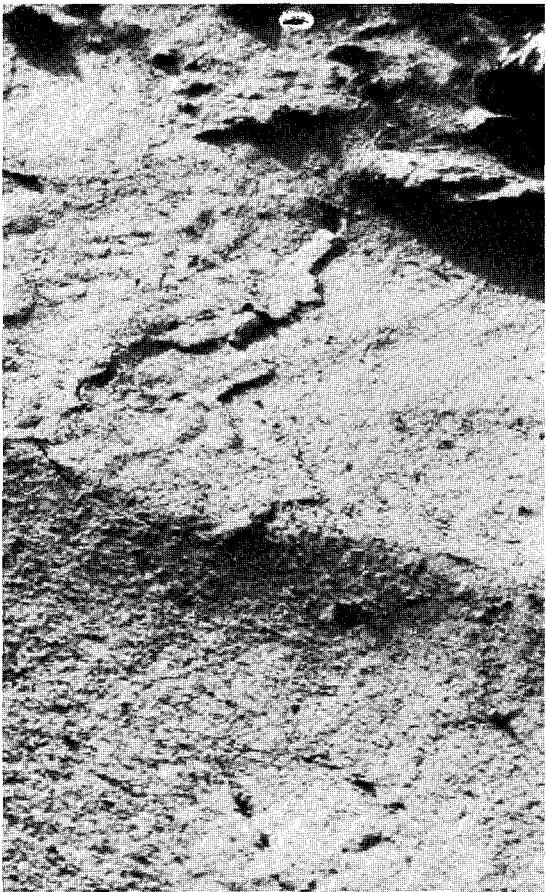
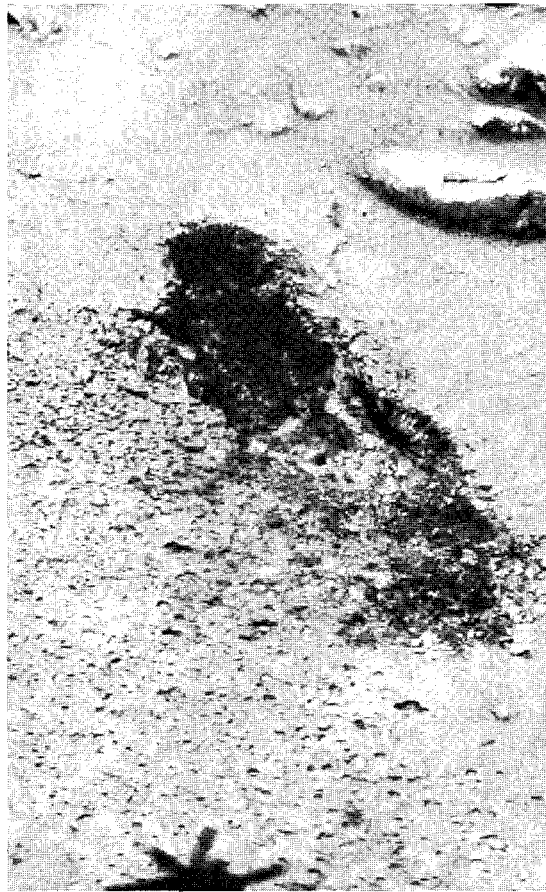
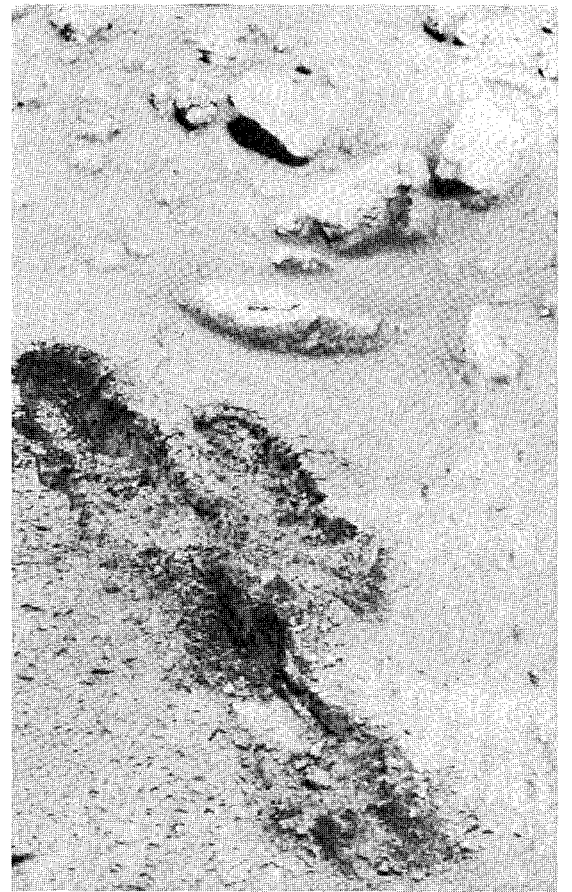
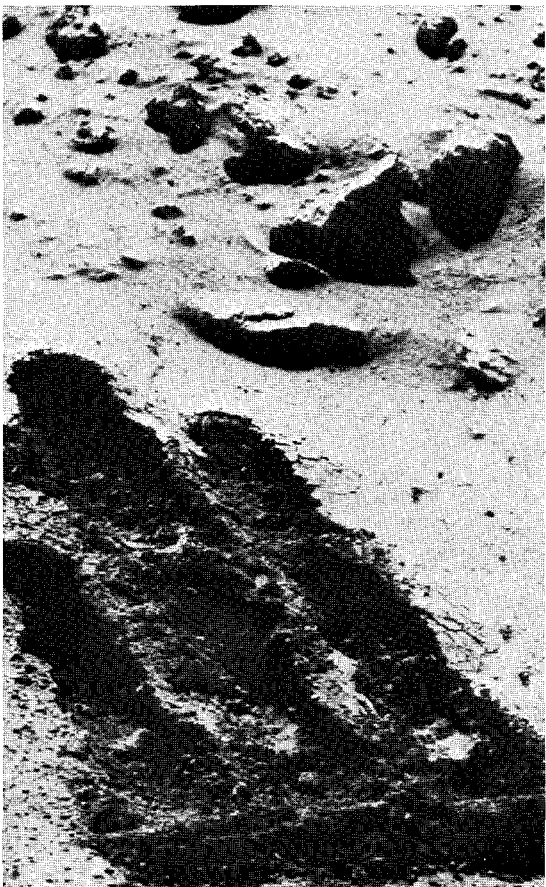
We were fortunate that martian surface materials were unconsolidated and relatively easy to shovel. Figures 157 through 161 show the progressive excavation of an area at the Lander 1 site known as Sandy Flats. Over a period of 10 months, more than a dozen individual trenching operations at Sandy Flats were completed. After it had been determined that

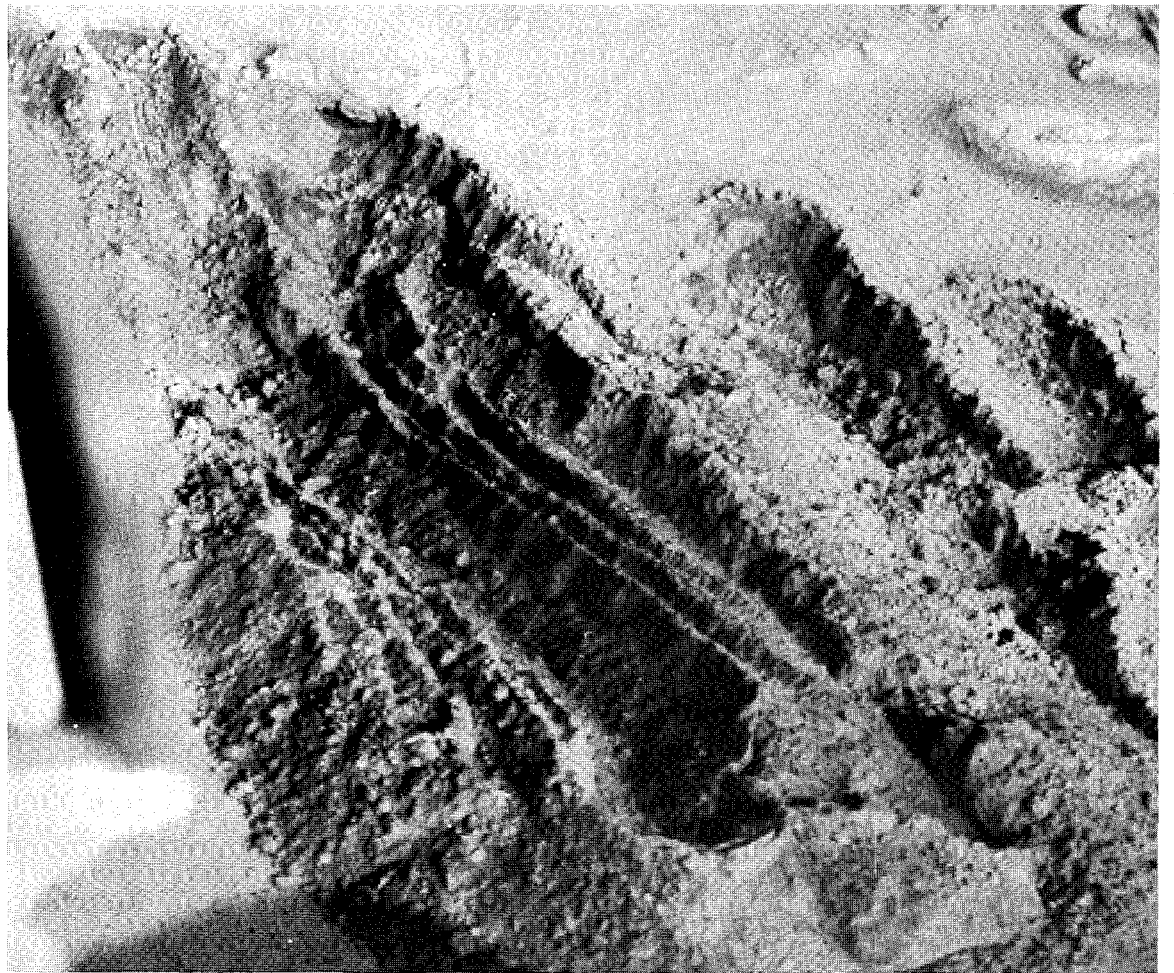
FIGURE 161

the upper soil was biologically sterile, some scientists speculated that organisms might exist deeper in the soil where they would be protected from deadly ultraviolet radiation. The thesis was tested by repeatedly digging at the same spot until a hole more than 15 cm in depth was excavated (fig. 161). In one sense this was a sophisticated engineering task, requiring complicated sequences of sampler-arm commands. In another sense it was reminiscent of childhood exercises with sand and shovel. At any rate, it was to no avail. Samples yielded negative biological results.

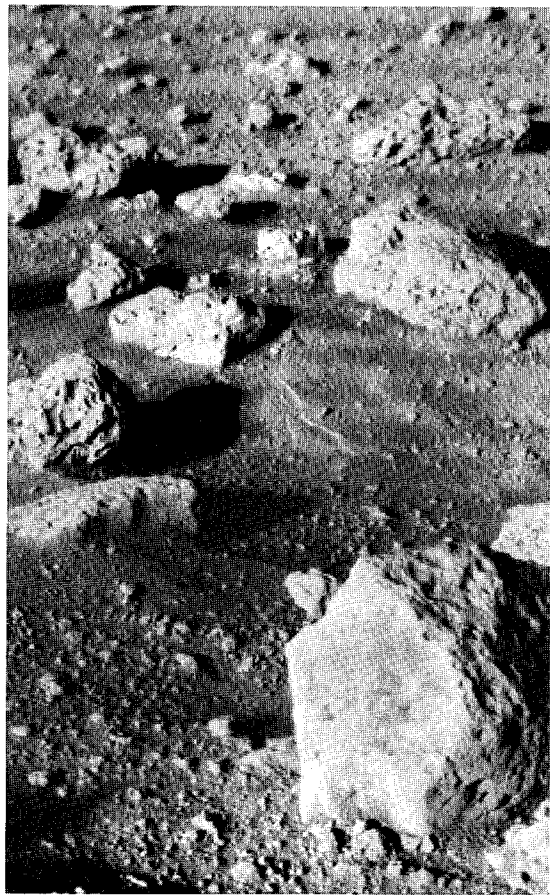
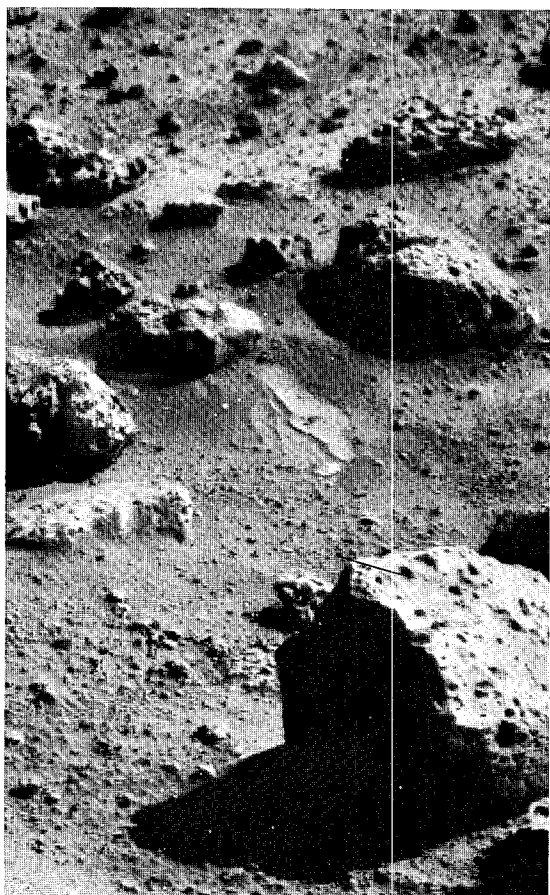
Figures 162 through 164 record sampling of a duricrust layer at the Lander 2 site. Figures 162 and 163 are two views of the area before sampling. Because this small exposure of duricrust was nestled between large blocks, engineers were concerned that the sampler arm might be damaged by inadvertently striking one of the boulders. Stereoscopic analysis of picture pairs indicated that the duricrust was accessible, but that the arm would come very close to several potentially disabling obstacles. Our nervousness was dispelled only when we received a picture showing the virtual obliteration of the duricrust patch (fig. 164).

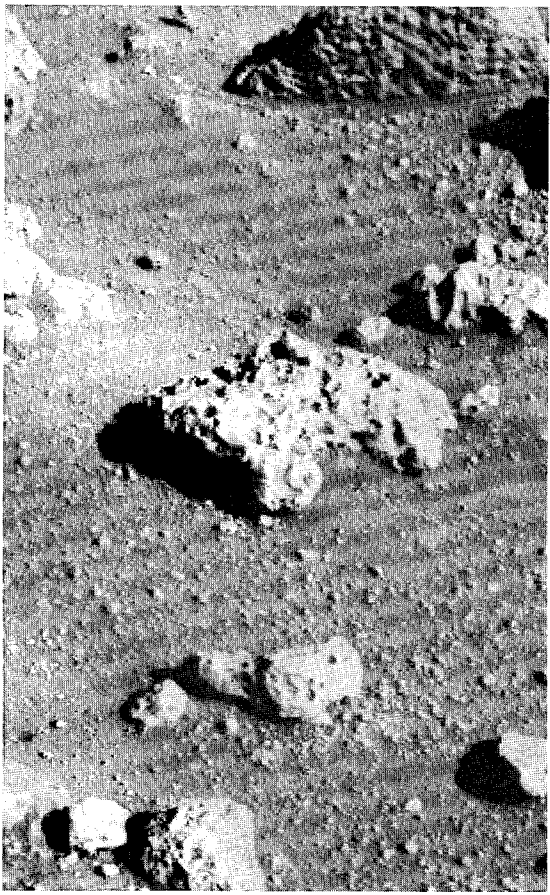
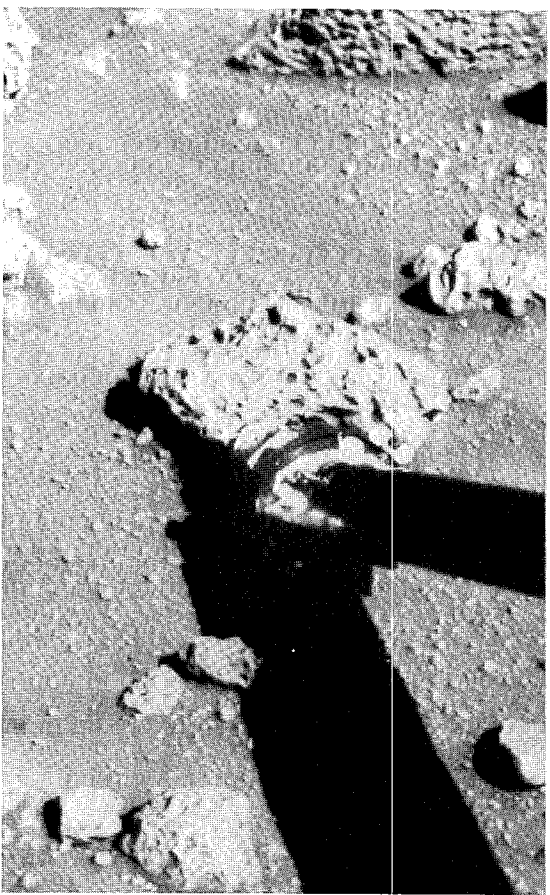
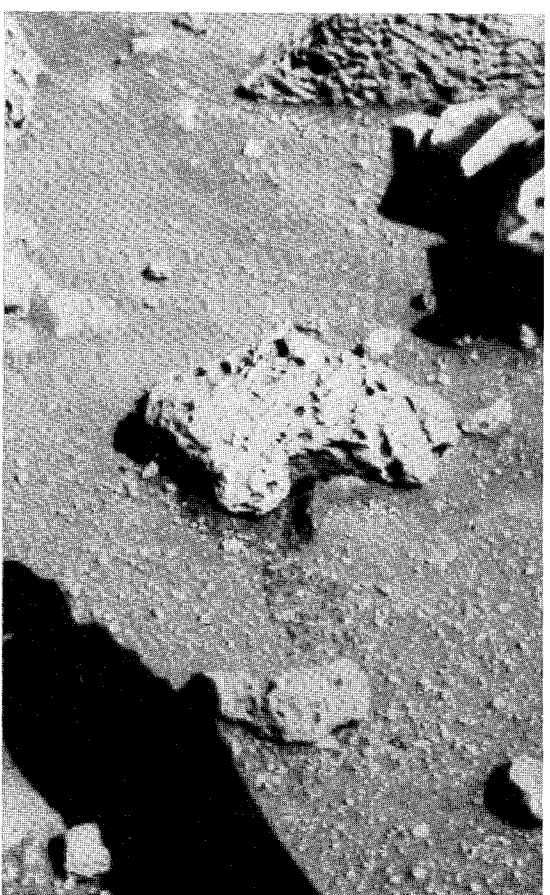
In the search for martian organisms it was suggested that material from under rocks might be an attractive environment for organisms (protected from the sterilizing effects of the solar ultraviolet). Figures 165 through 167 show a boulder (nicknamed "Notch Rock") at the Lander 2 site that was successfully nudged to one side. Figure 165 is the "before" picture. Figure 166 shows the sampler arm midway through its pushing operation. Figure 167 shows the completed activity. The rock has been moved approximately 3 cm. A small depression is visible in front of the rock where it had previously been partially buried by surface material. Again, no organisms were found.
